CRASH INJURY INVESTIGATION

HU-1A BELL IROQUOIS HELICOPTER ACCIDENT

East St. Louis, Illinois

21 October 1959

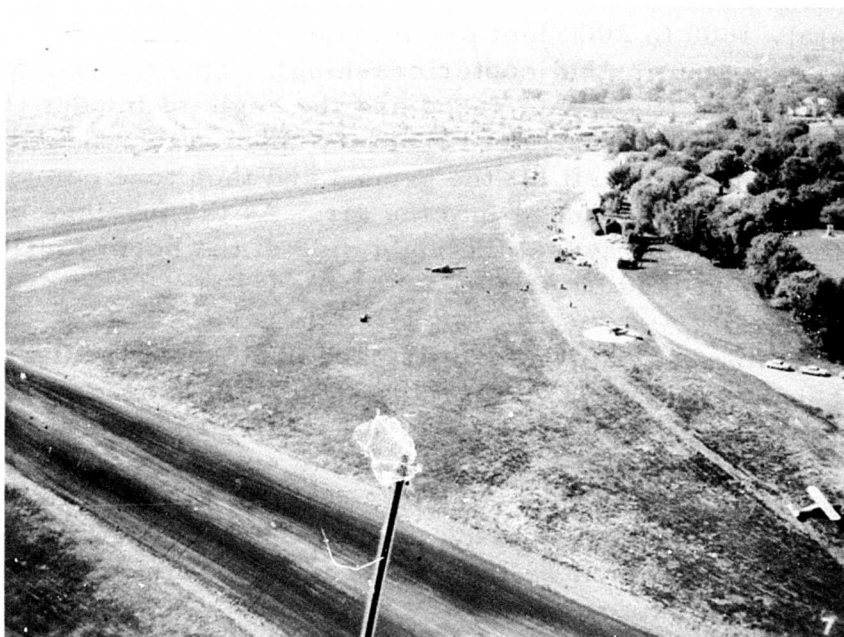
Fig. 1. The aircraft approached the field as indicated by the arrow.

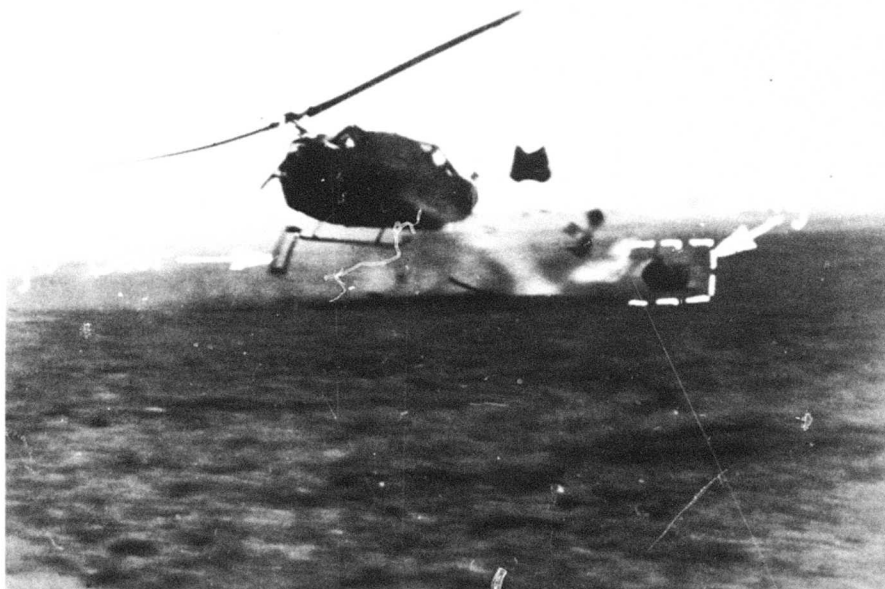
Fig. 4. View of right side and underside of HU-1A (nose is at the right), airborne after second impact about 350 feet along crash path. Note that engine is torn free, hurtling ahead of fuselage; slight displacement of rotor head to left is indicated.

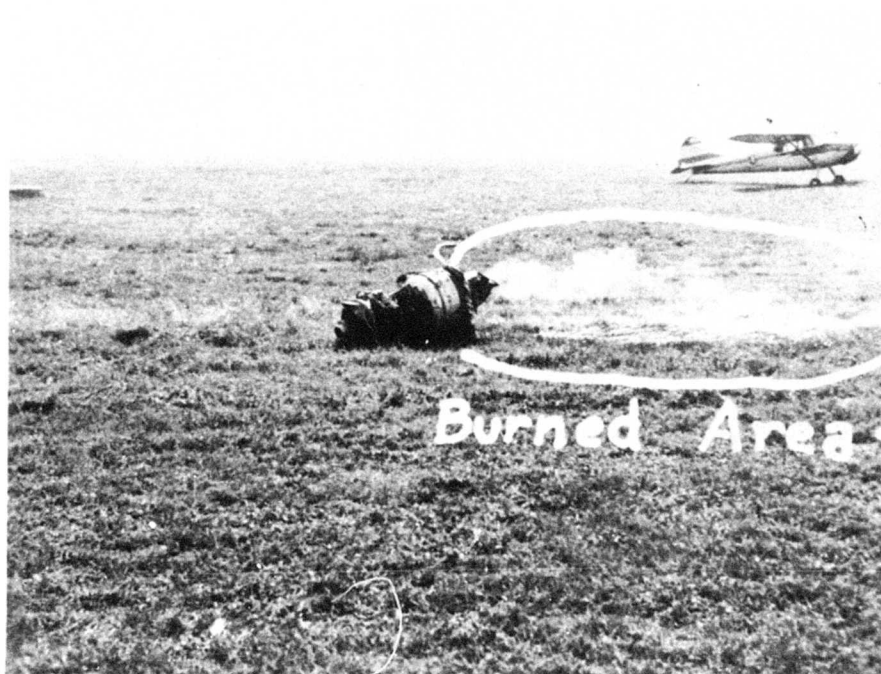
Fig. 7. Engine continued to run for a few seconds after being torn free.

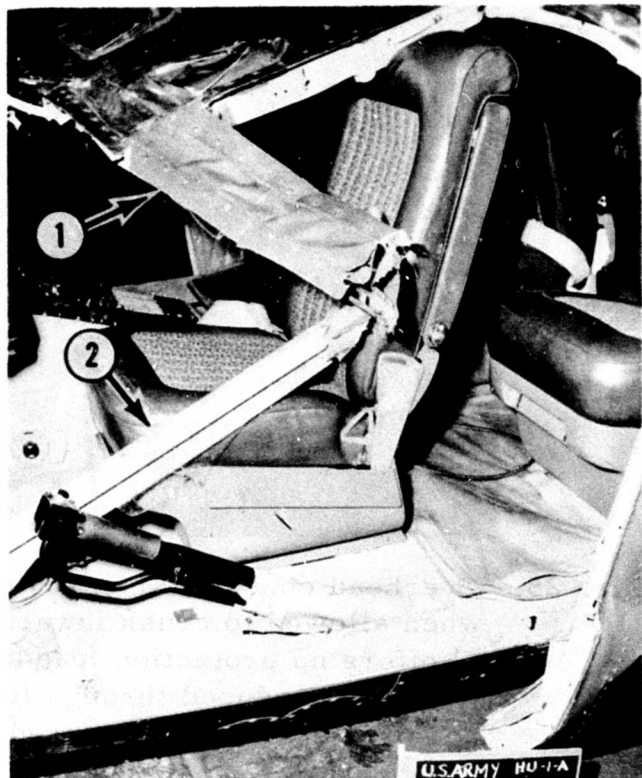
Fig. 23. Copilot's (left) overhead window frame (arrow 1) and left forward door post (arrow 2) were crushed inward.

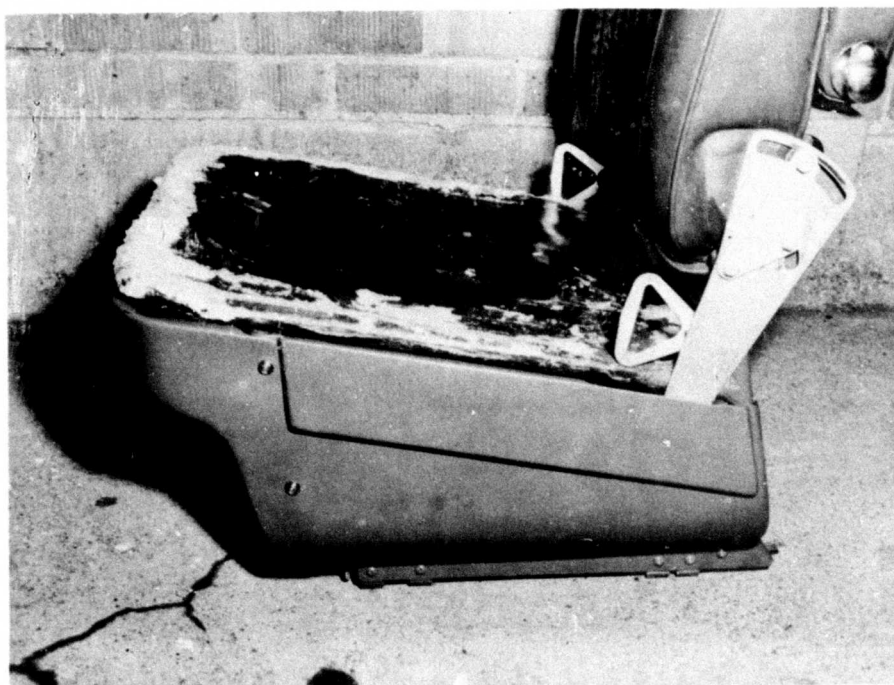
Fig. 63. Side view of seat pan.
